INSPECTION REPORT FROM SCOTT'S HOME INSPECTIONS

1234 Main Street
Fulton, MO 65251

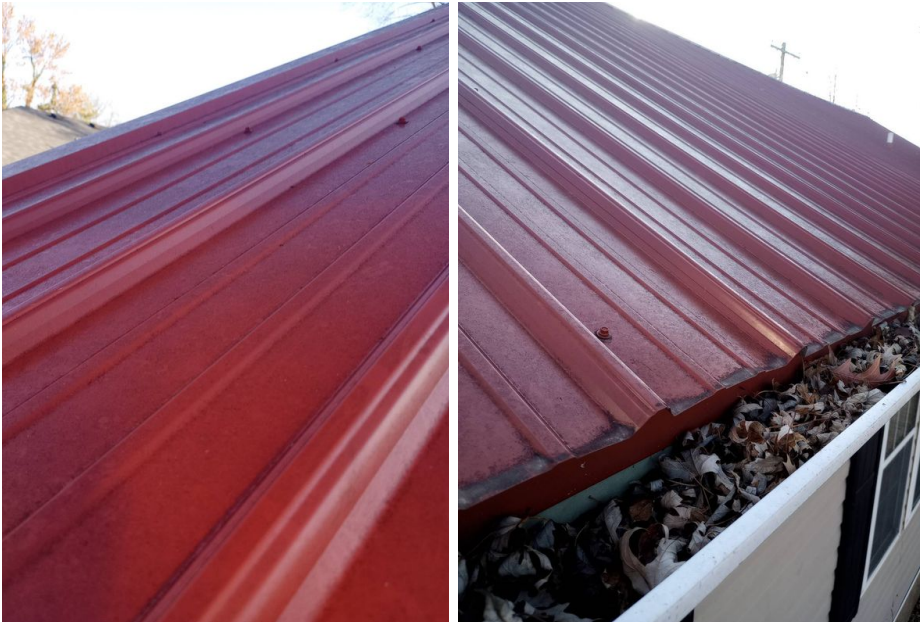
Roof Covering: Type of Roof-Covering Described

Metal

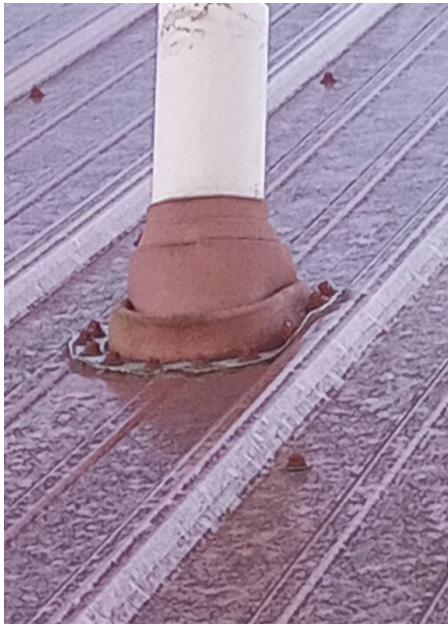
Plumbing Vent Pipes: Plumbing Vent Pipes Inspected

I looked at DWV (drain, waste and vent) pipes that pass through the roof covering. There should be watertight flashing (often black rubber material) installed around the vent pipes. These plumbing vent pipes should extend far enough above the roof surface.

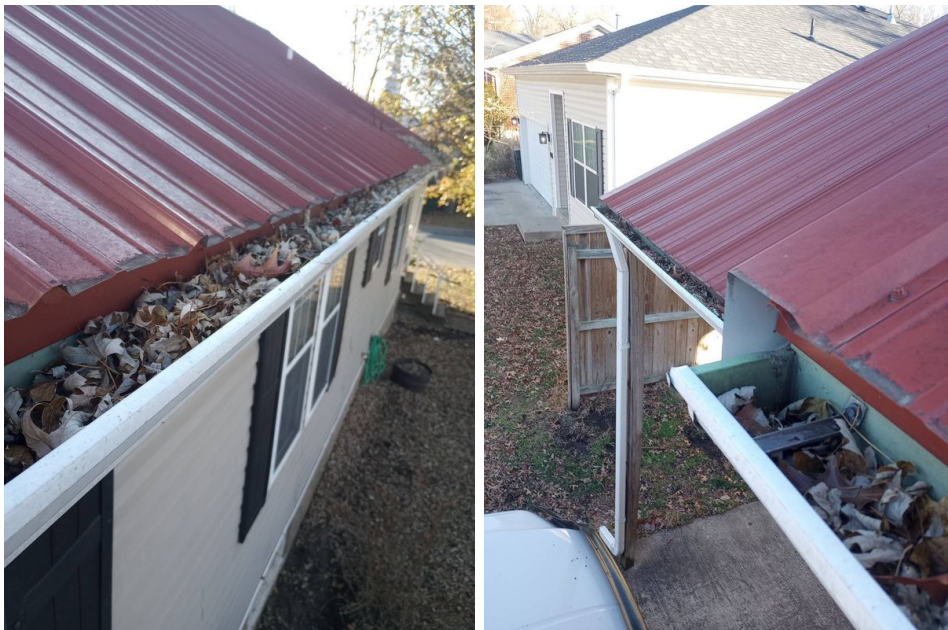
I observed debris in the gutter. Cleaning and maintenance is recommended.

Recommendation

Contact a handyman or DIY project

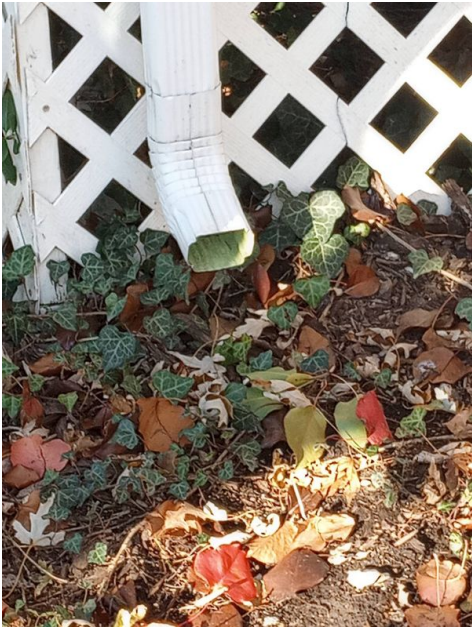
Eastside front porch

I observed indications that the water diverter tray or splash block at the downspout end is needed Easy to do.

Recommendation

Recommended DIY Project

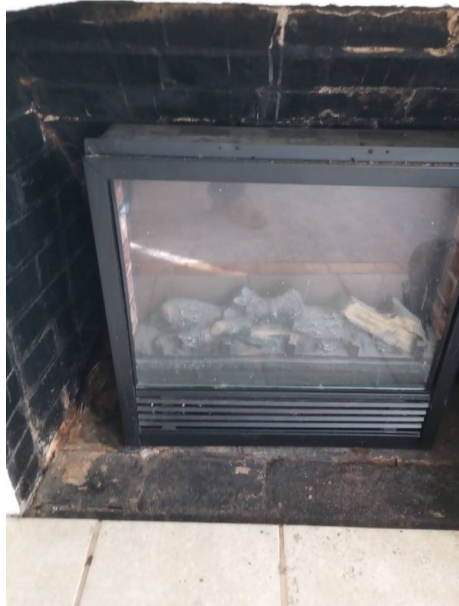
Electric fireplace

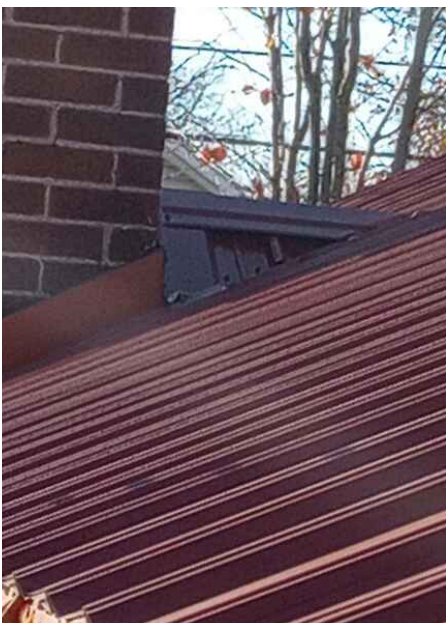
Flashing at Chimney

Masonry Chimney: Masonry Chimney Flashing Was Inspected

I inspected for flashing installed at the chimney.

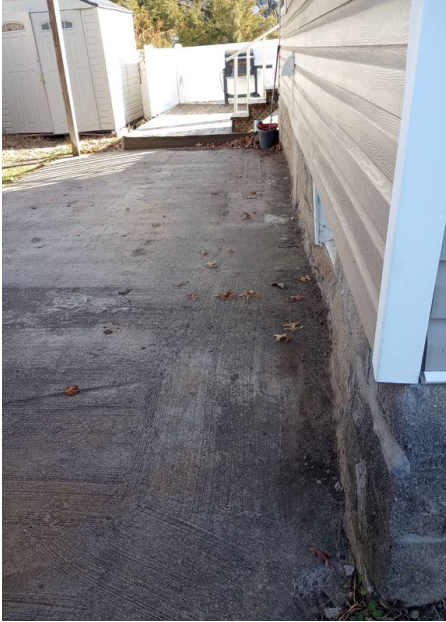
Concrete pad under carport is sloping towards the house

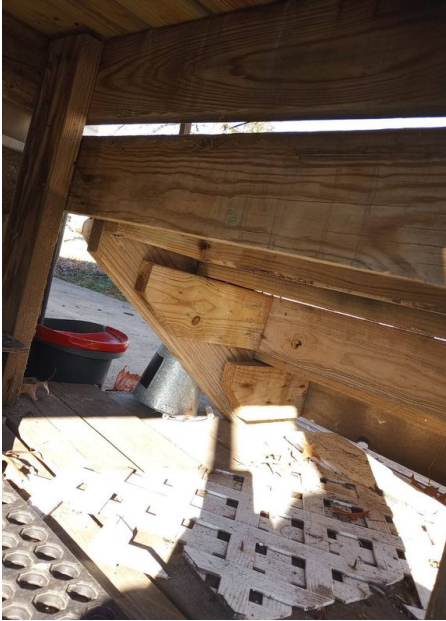
Back porch steps

I inspected the stairs, steps, stoops, stairways and ramps that were within the scope of my home inspection.

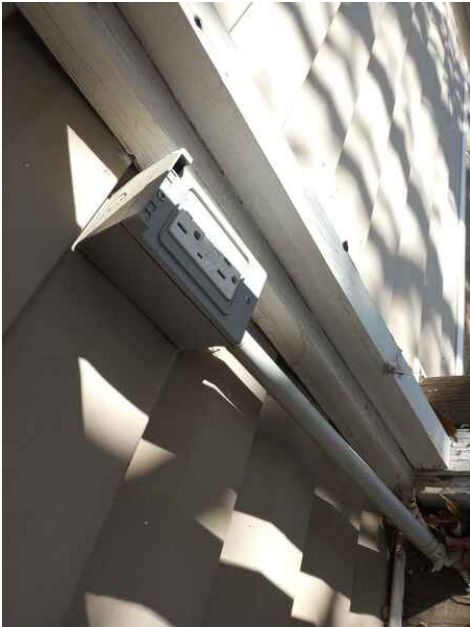
GFCI ON FRONT PORCH MISSING COVER

Missing Cover

Recommendation

Contact a handyman or DIY project

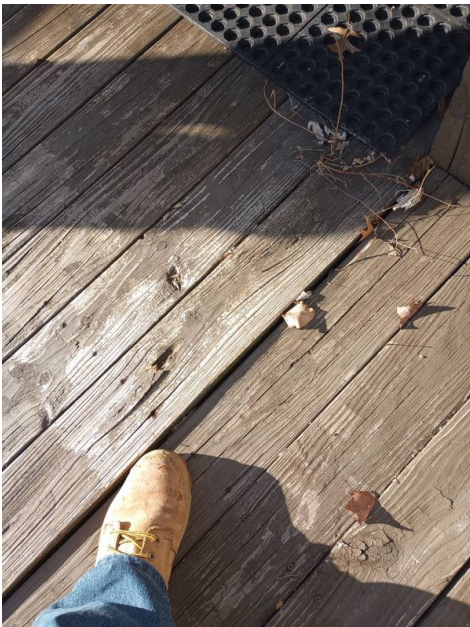
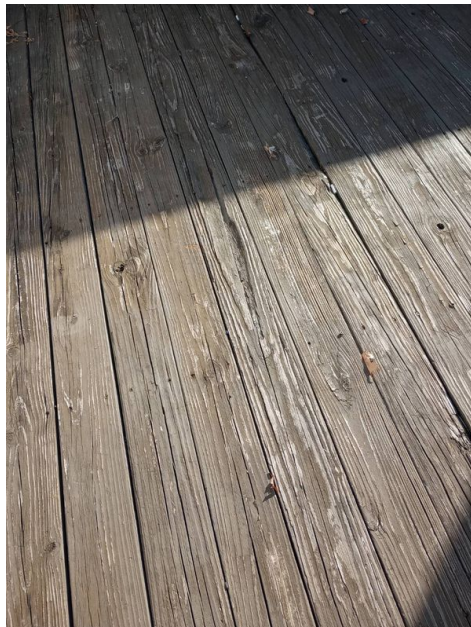
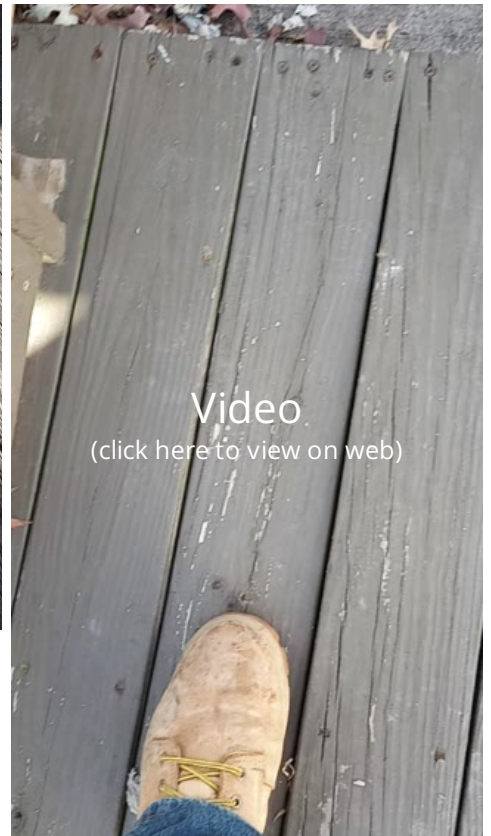
DETERIORATED CONDITION AT DECK

I observed indications of deteriorated conditions at the deck components. Some areas are weather worn.

Recommendation

Contact a qualified deck contractor.

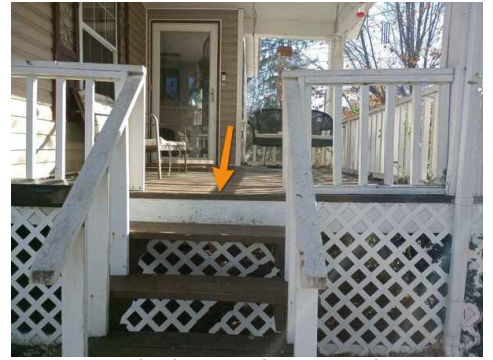
DECK - INADEQUATE STRUCTURAL COMPONENT

I observed a structural defect at the deck. The deck's structural condition is inadequate. This is a major defect.

Front porch sloping downward

Correction and further evaluation of the deck is recommended.

Recommendation

Contact a qualified deck contractor.

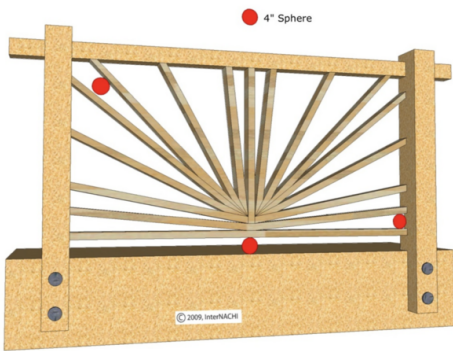
I observed improper spacing between intermediate balusters, spindles and rails at a required guard. This is a safety hazard, especially for small children.

4-inch sphere opening at a guard

Correction and further evaluation is recommended.

Recommendation

Contact a qualified general contractor.

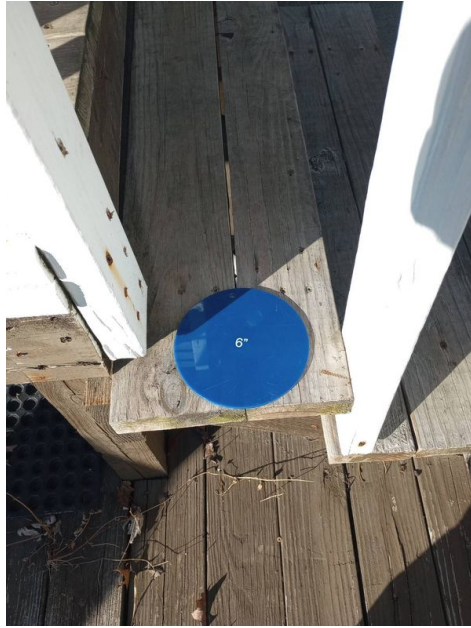
Back porch

I observed improper spacing between intermediate balusters, spindles and rails. This is a safety hazard, especially for small children.

Correction and further evaluation is recommended.

Recommendation

Contact a qualified general contractor.

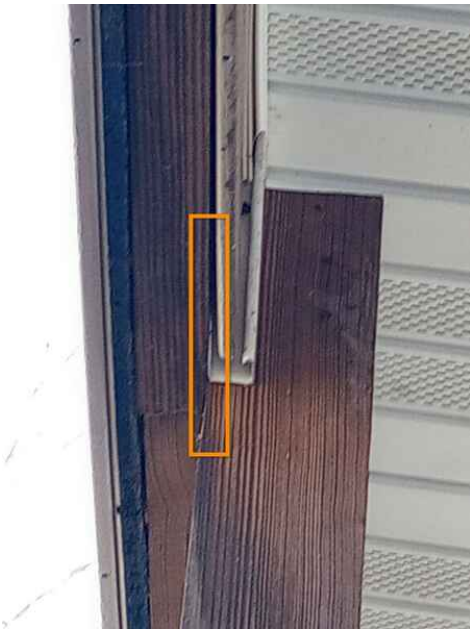
STRUCTURAL DEFECT

I observed a major structural defect at the carport. .

Not resting on the top of the post

Recommendation

Contact a qualified general contractor.

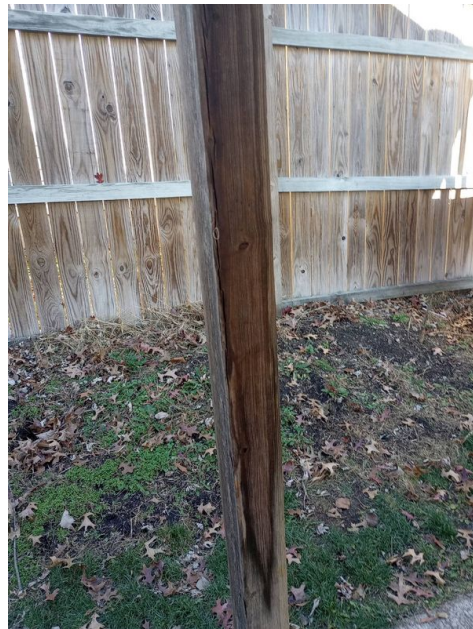
At least a 6x6 should have been used

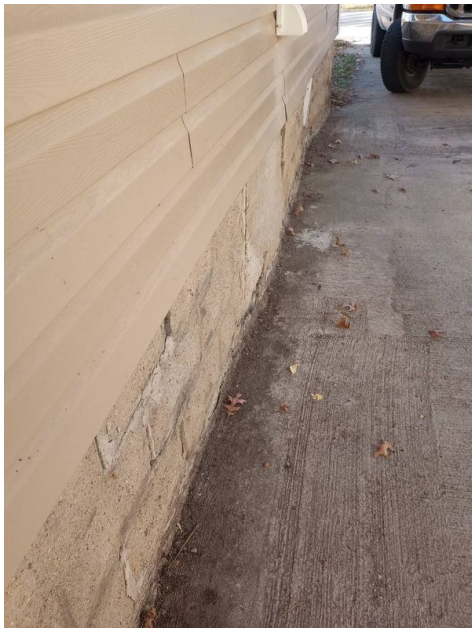
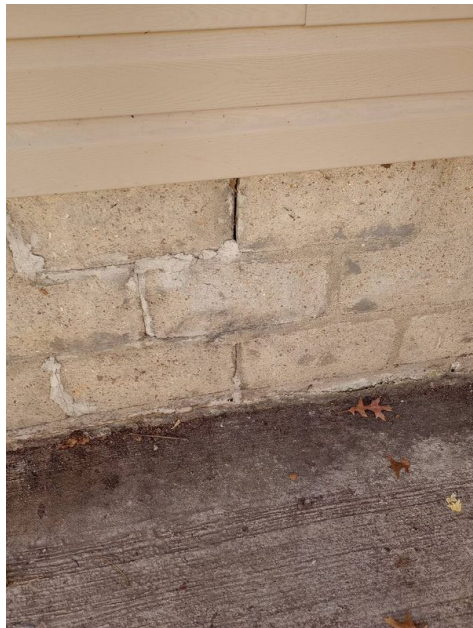
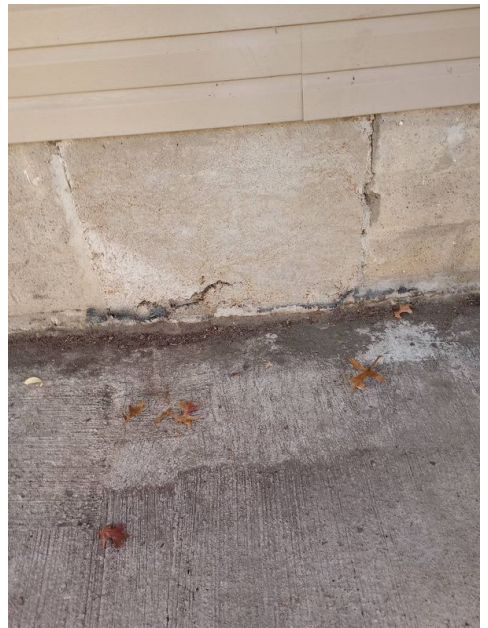
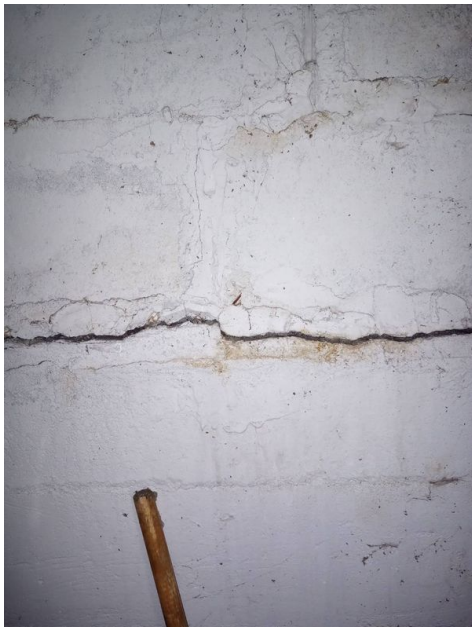
FOUNDATION CRACK - MAJOR

I observed a major crack at the structural wall of the house foundation.

I am not a structural engineer. I recommend a structural engineer further evaluate and make recommendations related to this observation.

Recommendation

Contact a qualified structural engineer.

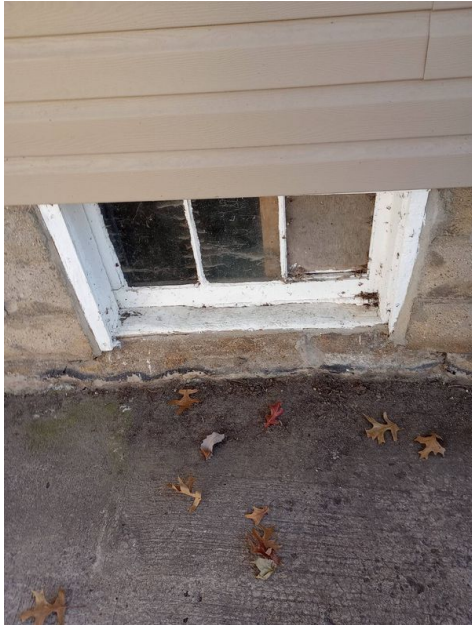
FOUNDATION WALL LEANING

I observed indications of a leaning foundation wall. This is a major defect. Correction and further evaluation is recommended.

You can see significant leaning on this window under the carport

Recommendation

Contact a qualified structural engineer.

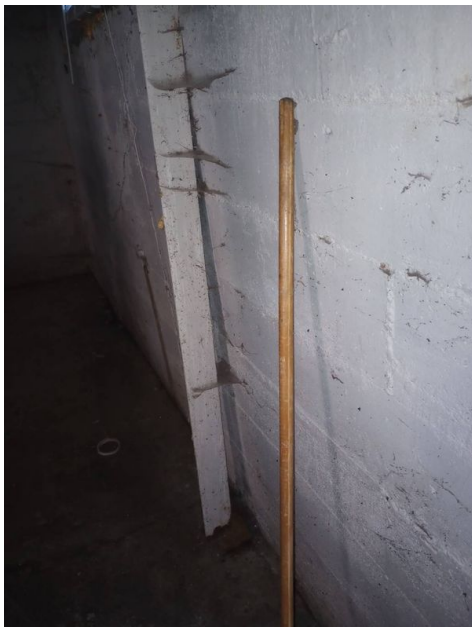
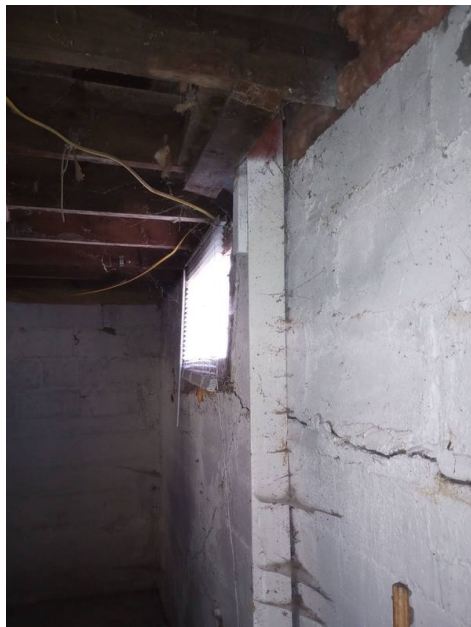
6.1.4 Basement

HEAVING & SETTLING OF CONCRETE FLOOR

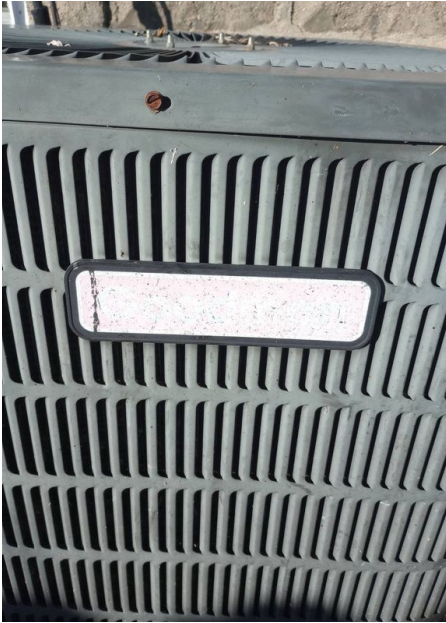
Manufacturer is Goodman

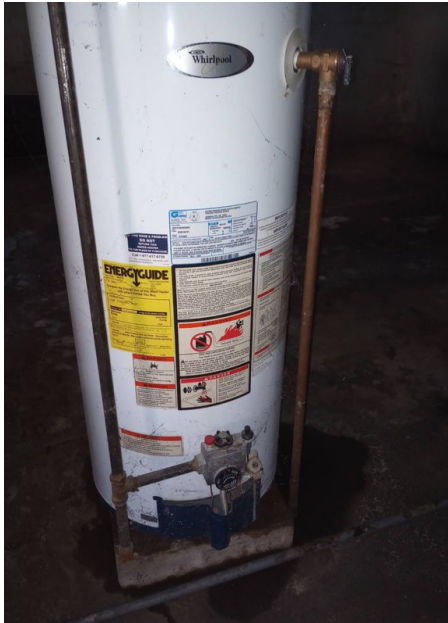
Gas-Fired Hot Water Tank

I inspected for the main source of the distributed hot water to the plumbing fixtures (sinks, tubs, showers). I recommend asking the homeowner for details about the hot water equipment and past performance.

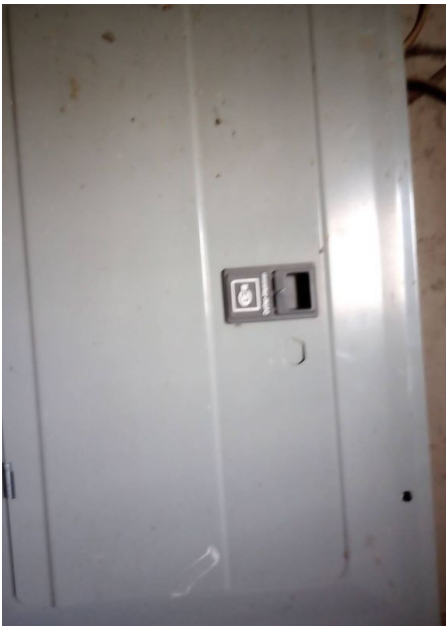
Main Service Disconnect: Main Disconnect Rating, If Labeled

100

I observed indications of the main service disconnect's amperage rating. It was labeled.

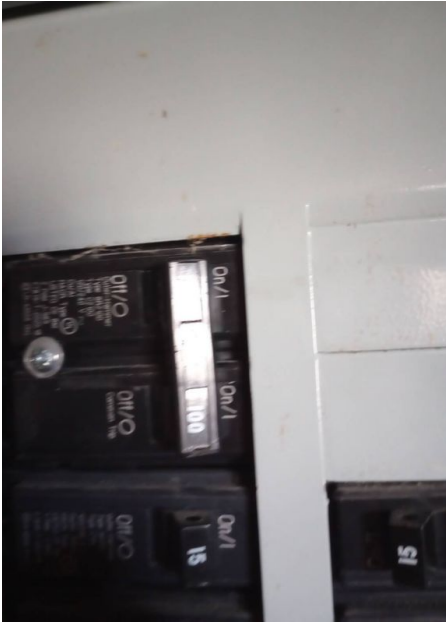
**Panelboards & Breakers: Inspected Main Panelboard & Breakers**

I inspected the electrical panelboards and over-current protection devices (circuit breakers and fuses).

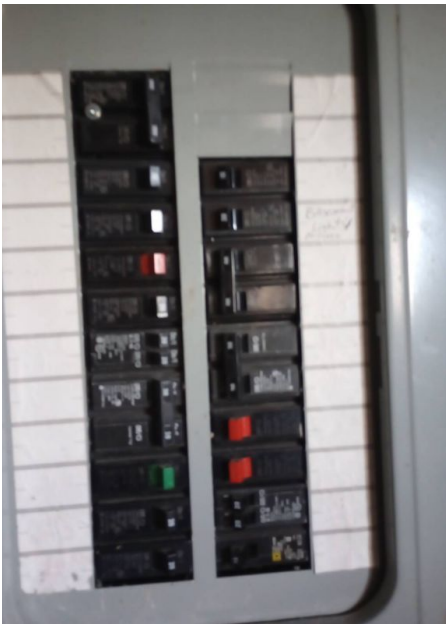
**Panelboards & Breakers: Inspected Subpanel & Breakers**

I inspected the electrical subpanel and over-current protection devices (circuit breakers and fuses).

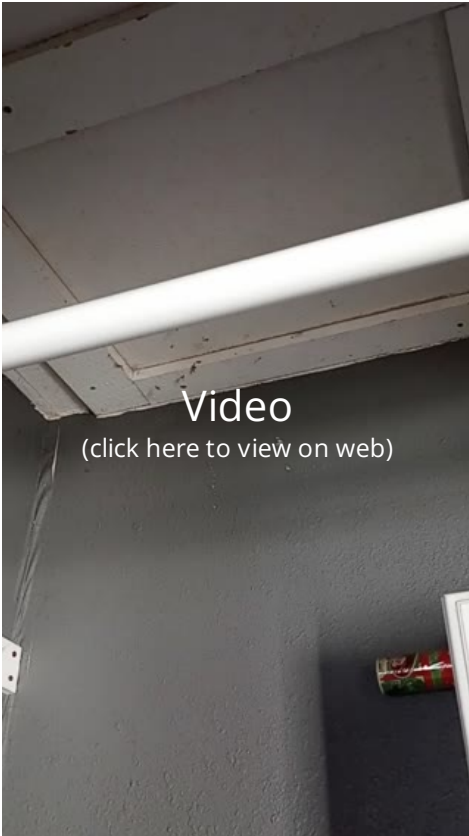
ATTIC ACCESS UNAVAILABLE.

There is an attic access in the laundry room above the washer. But unable to access said opening because the washer is in the way. The inspector is not allowed to unhook or move the washer for access.

Insulation in Attic

UNABLE TO ACCESS
